PRESAJET SAPI DE CV DBA CROWN BUILDING PRODUCTS TEST REPORT

FM 4473 IMPACT RESISTANCE TESTING OF MEDITERRANEAN ROOF TILE

P5633.02-801-44 R1

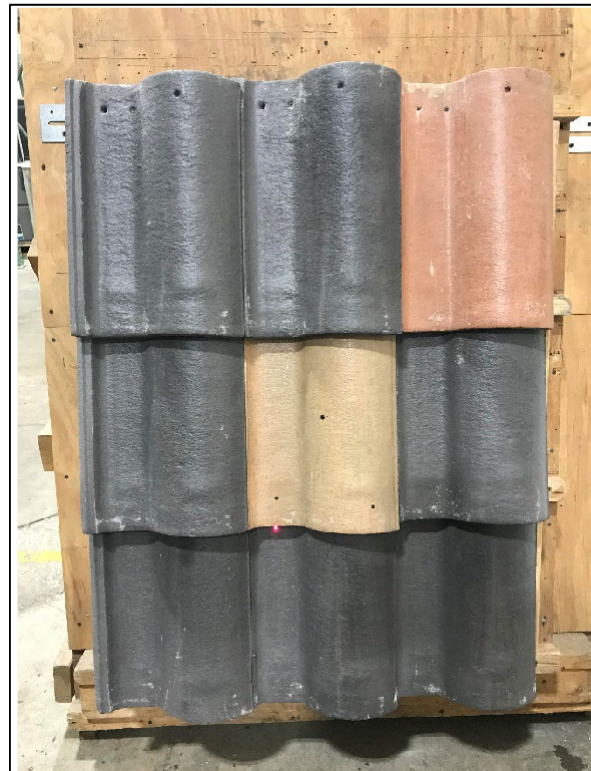
**Photo No. 1
Test Deck, Overall View**

Installation of the tested product was performed by Intertek Building & Construction (B&C). 1x2 wood battens were secured to the deck with #8 x 2-1/2" wood screws located on 18" centers. Battens were spaced 14" on center from the bottom. Tiles were placed on the battens in overlapped weatherboard fashion and secured with #8 x 2-1/2" located in one nail hole. Tiles overlapped 3" at the bottom and 1" at the sides.

The wood test deck was 3' wide x 4' high and constructed with 2x4 pine construction lumber at the perimeter with one stud located at the midspan. The test deck was covered with 15/32" thick plywood decking secured to the test deck with #6 x 1-5/8" screws located 2" from each end and on 6" centers.

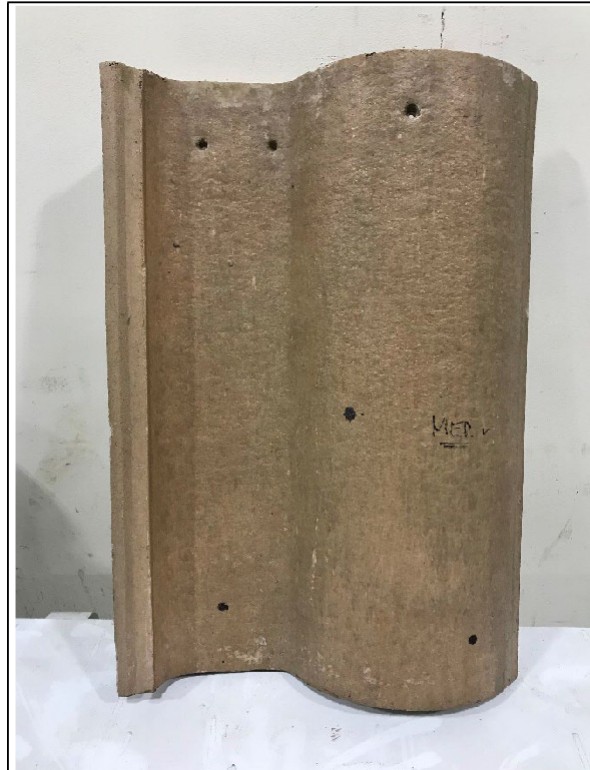
Photo No. 2
Impact Tile, Front View

IMPACT	MISSILE					IMPACT AREA	OBSERVATIONS	RESULTS
	VELOCITY m/s (fps)	ORIENTATION	WEIGHT g (lbs)	DIAMETER mm (in.)	ENERGY ft-lb			
1	31.4 (102.9)	15° of vertical	66.6 (0.147)	50.8 (2.0)	24.16	Bottom left corner, 2" from bottom	No visible cracking or breakage	Pass
2	31.9 (104.6)	15° of vertical	65.2 (0.144)	50.8 (2.0)	24.44	Bottom left corner, 2" from bottom	No visible cracking or breakage	Pass
3	31.9 (104.6)	15° of vertical	65.4 (0.144)	50.8 (2.0)	24.52	Center, 8" from bottom	No visible cracking or breakage	Pass
4	31.7 (104.0)	15° of vertical	64.5 (0.142)	50.8 (2.0)	23.90	Center, 8" from bottom	No visible cracking or breakage	Pass
5	31.9 (104.6)	15° of vertical	64.4 (0.142)	50.8 (2.0)	24.14	Bottom right corner, 2" from bottom	No visible cracking or breakage	Pass
6	33.1 (108.6)	15° of vertical	64.6 (0.142)	50.8 (2.0)	26.11	Bottom right corner, 2" from bottom	No visible cracking or breakage	Pass

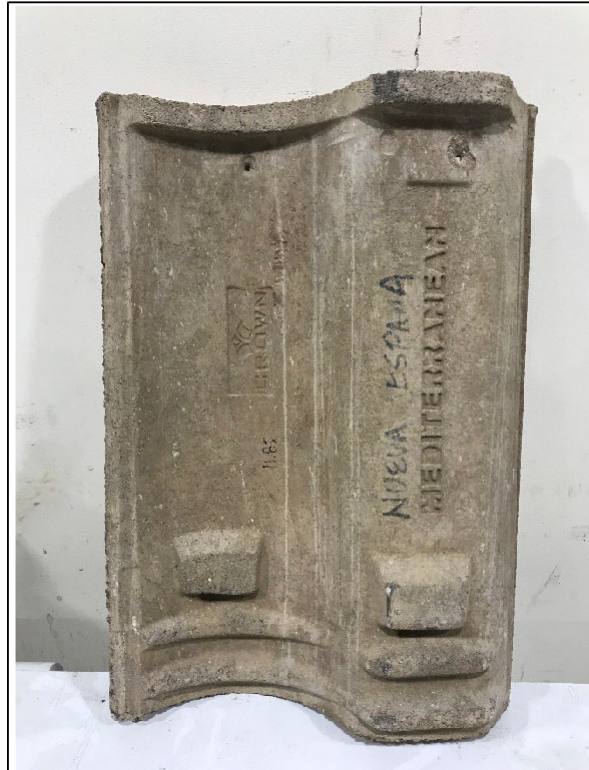
Photo No. 3
Impact Tile, Rear View
