PRESAJET SAPI DE CV DBA CROWN BUILDING PRODUCTS TEST REPORT

FM 4473 IMPACT RESISTANCE TESTING OF IBERIA ROOF TILE

P5633.01-801-44 R1

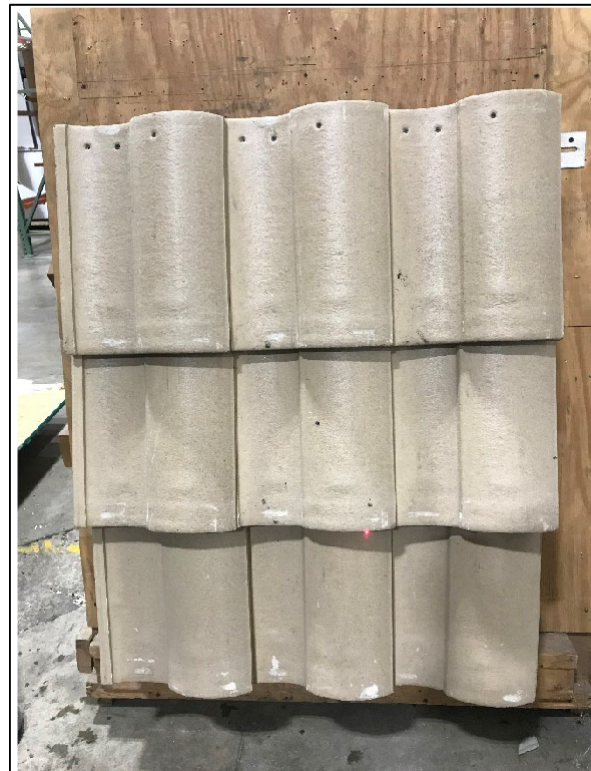
Photo No. 1
Test Deck, Overall View

Installation of the tested product was performed by Intertek Building & Construction (B&C). 1x2 wood battens were secured to the deck with #8 x 2-1/2" wood screws located on 18" centers. Battens were spaced 14" on center from the bottom. Tiles were placed on the battens in overlapped weatherboard fashion and secured with #8 x 2-1/2" located in one nail hole. Tiles overlapped 3" at the bottom and 1" at the sides.

The wood test deck was 3' wide x 4' high and constructed with 2x4 pine construction lumber at the perimeter with one stud located at the midspan. The test deck was covered with 15/32" thick plywood decking secured to the test deck with #6 x 1-5/8" screws located 2" from each end and on 6" centers.

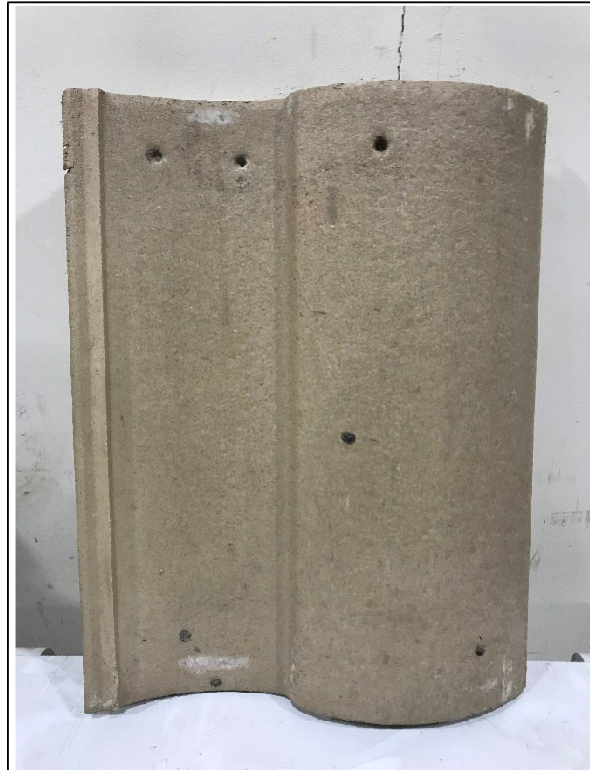
Photo No. 2
Impact Tile, Front View

IMPACT	MISSILE					IMPACT AREA	OBSERVATIONS	RESULTS
	VELOCITY m/s (fps)	ORIENTATION	WEIGHT g (lbs)	DIAMETER mm (in.)	ENERGY ft-lb			
1	31.2 (102.4)	15° of vertical	42.8 (0.094)	44.5 (1.75)	15.38	Bottom left corner, 2" from bottom	No visible cracking or breakage	Pass
2	30.1 (98.6)	15° of vertical	42.1 (0.093)	44.5 (1.75)	14.02	Bottom left corner, 2" from bottom	No visible cracking or breakage	Pass
3	30.7 (100.8)	15° of vertical	42.1 (0.093)	44.5 (1.75)	14.66	Center, 8" from bottom	No visible cracking or breakage	Pass
4	31.5 (103.3)	15° of vertical	42.1 (0.093)	44.5 (1.75)	15.39	Center, 8" from bottom	No visible cracking or breakage	Pass
5	30.1 (98.6)	15° of vertical	42.1 (0.093)	44.5 (1.75)	14.02	Bottom right corner, 2" from bottom	No visible cracking or breakage	Pass
6	30.1 (98.6)	15° of vertical	42.1 (0.093)	44.5 (1.75)	14.02	Bottom right corner, 2" from bottom	No visible cracking or breakage	Pass

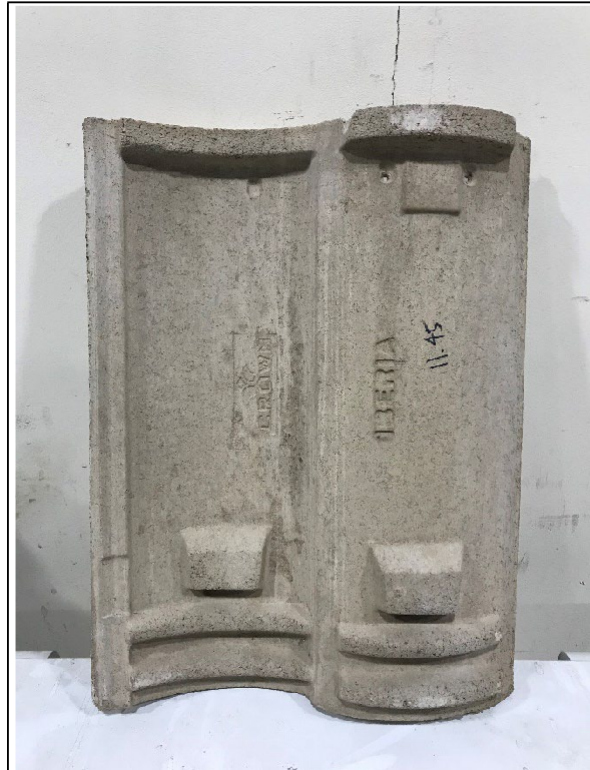
Photo No. 3
Impact Tile, Rear View
