PRESAJET SAPI DE CV DBA CROWN BUILDING PRODUCTS TEST REPORT

FM 4473 IMPACT RESISTANCE TESTING OF TUSCANY ROOF TILE

P5633.03-801-44 R1

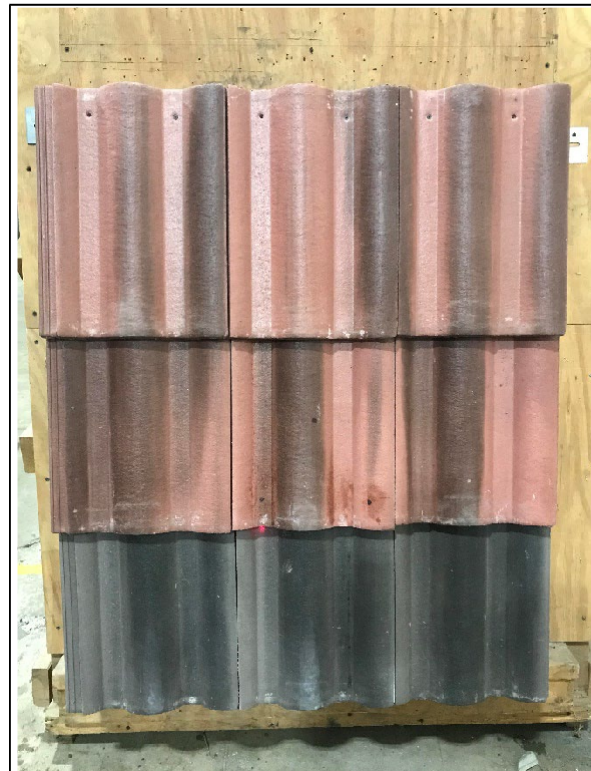
Photo No. 1
Test Deck, Overall View

Installation of the tested product was performed by Intertek Building & Construction (B&C). 1x2 wood battens were secured to the deck with #8 x 2-1/2" wood screws located on 18" centers. Battens were spaced 14" on center from the bottom. Tiles were placed on the battens in overlapped weatherboard fashion and secured with #8 x 2-1/2" located in one nail hole. Tiles overlapped 3" at the bottom and 1" at the sides.

The wood test deck was 3' wide x 4' high and constructed with 2x4 pine construction lumber at the perimeter with one stud located at the midspan. The test deck was covered with 15/32" thick plywood decking secured to the test deck with #6 x 1-5/8" screws located 2" from each end and on 6" centers.

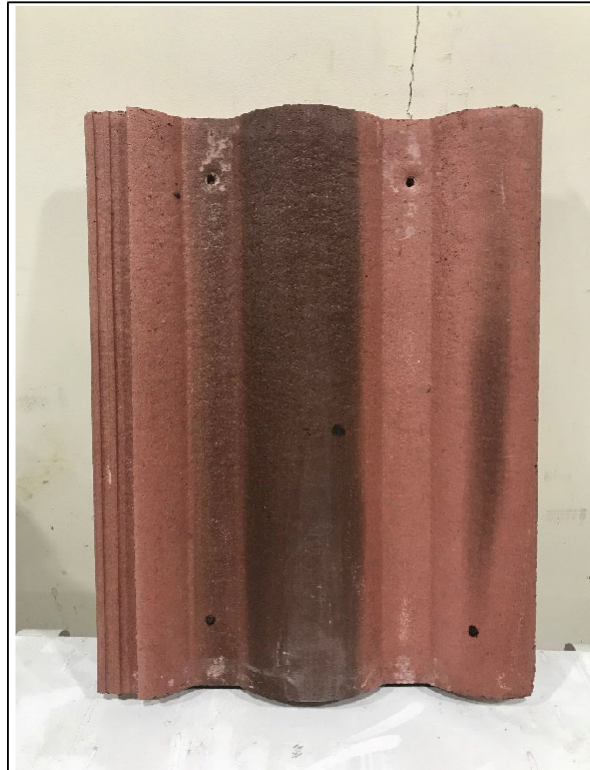
**Photo No. 2
Impact Tile, Front View**

IMPACT	MISSILE					IMPACT AREA	OBSERVATIONS	RESULTS
	VELOCITY m/s (fps)	ORIENTATION	WEIGHT g (lbs)	DIAMETER mm (in.)	ENERGY ft-lb			
1	29.0 (95.3)	15° of vertical	45.0 (0.099)	44.5 (1.75)	14.00	Bottom left corner, 2" from bottom	No visible cracking or breakage	Pass
2	29.8 (97.8)	15° of vertical	42.9 (0.095)	44.5 (1.75)	14.06	Bottom left corner, 2" from bottom	No visible cracking or breakage	Pass
3	30.6 (100.3)	15° of vertical	42.1 (0.093)	44.5 (1.75)	14.51	Center, 8" from bottom	No visible cracking or breakage	Pass
4	30.1 (98.6)	15° of vertical	42.1 (0.093)	44.5 (1.75)	14.02	Center, 8" from bottom	No visible cracking or breakage	Pass
5	31.3 (102.8)	15° of vertical	42.5 (0.094)	44.5 (1.75)	15.39	Bottom right corner, 2" from bottom	No visible cracking or breakage	Pass
6	29.8 (97.9)	15° of vertical	42.7 (0.094)	44.5 (1.75)	14.02	Bottom right corner, 2" from bottom	No visible cracking or breakage	Pass

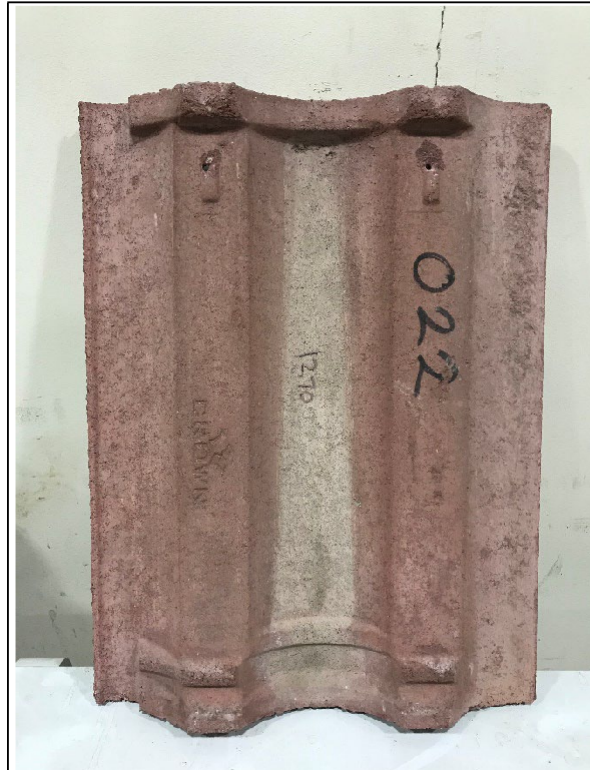
Photo No. 3
Impact Tile, Rear View
